**BIOREMEDIATION AND BIO-AUGMENTATION
MMABATHO WASTEWATER TREATMENT
WORKS (WWTW)**

FINAL REPORT

AUGUST 2019

Compiled by BioPower Corporation

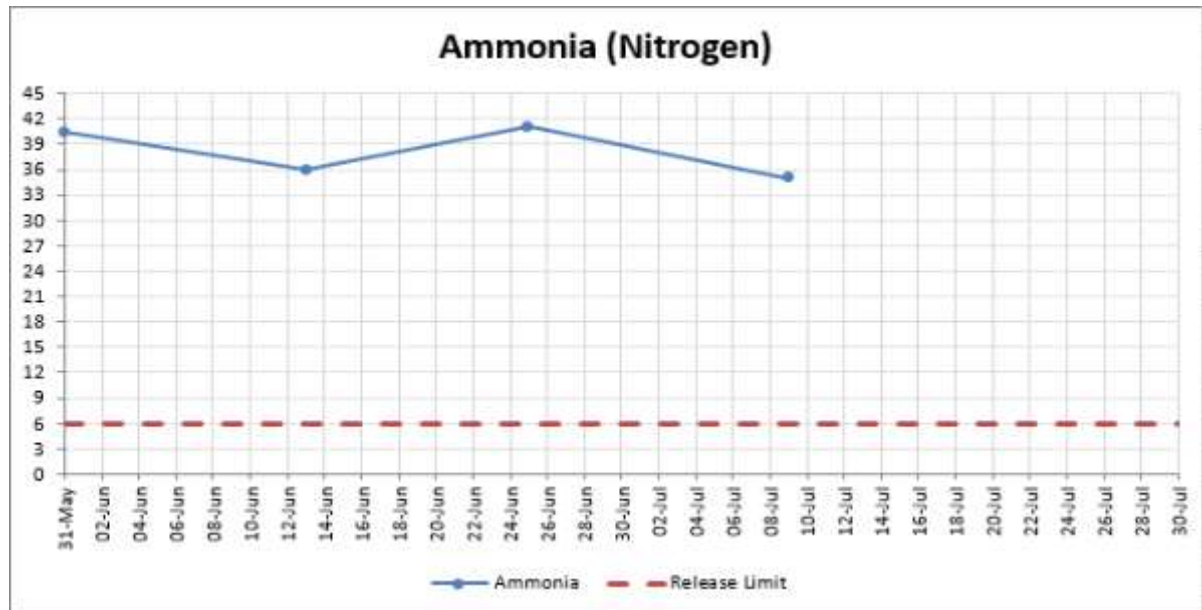
Ammonia (Nitrogen) levels showed a satisfactory drop over the period of the bioremediation programme, showing the effect of BioSol SL36. Vigorous aeration and mixing are needed for nitrification/denitrification processes. Non-operational mechanical equipment and excessive inflow of supposed blood through the inlet from the nearby abattoirs do play a deciding role in the counts to reach the desired standard.

Ammonia removal is a strictly aerobic biological process, and the following is needed:

- Generally, nitrification occurs only under aerobic conditions at dissolved oxygen levels of more than 1.0 mg/L
- Nitrification requires a long retention time
- A low food to microorganism ratio (F:M)
- A high mean cell residence time (measured as MCRT or Sludge Age)
- Adequate pH buffering (alkalinity)

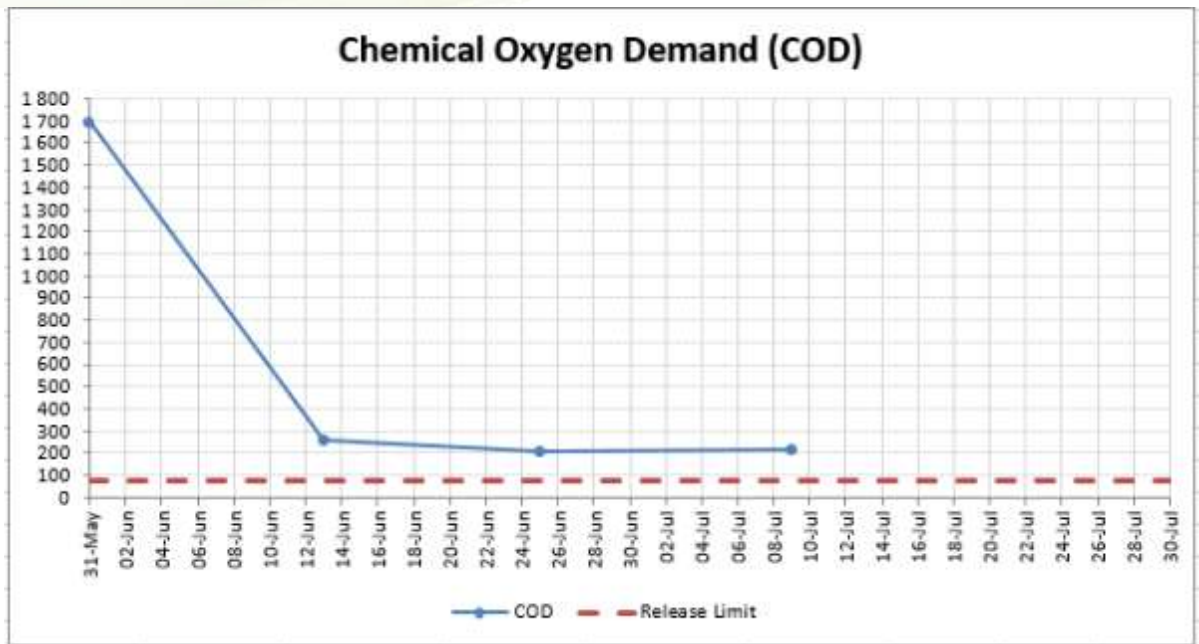
COD levels edging closer to compliance levels through the addition of BioSol SL36. With the continued use of BioSol SL36, COD levels will continue its shift towards the lawful standard.

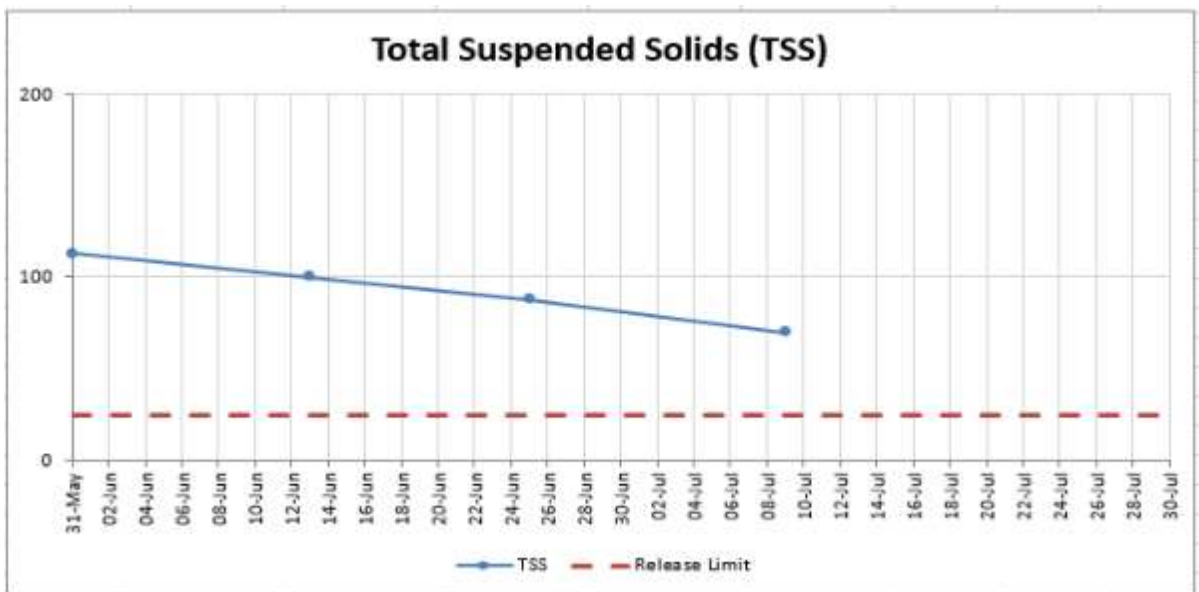
TSS levels continue to drop and is closing in on compliance levels with the addition of BioSol SL36. Total Suspended Solids (TSS) are solids in water that can be trapped by a filter. TSS can include a wide variety of material, such as silt, decaying WWTW and animal matter, industrial wastes, and sewage. High concentrations of suspended solids can cause many problems for stream health and aquatic life.

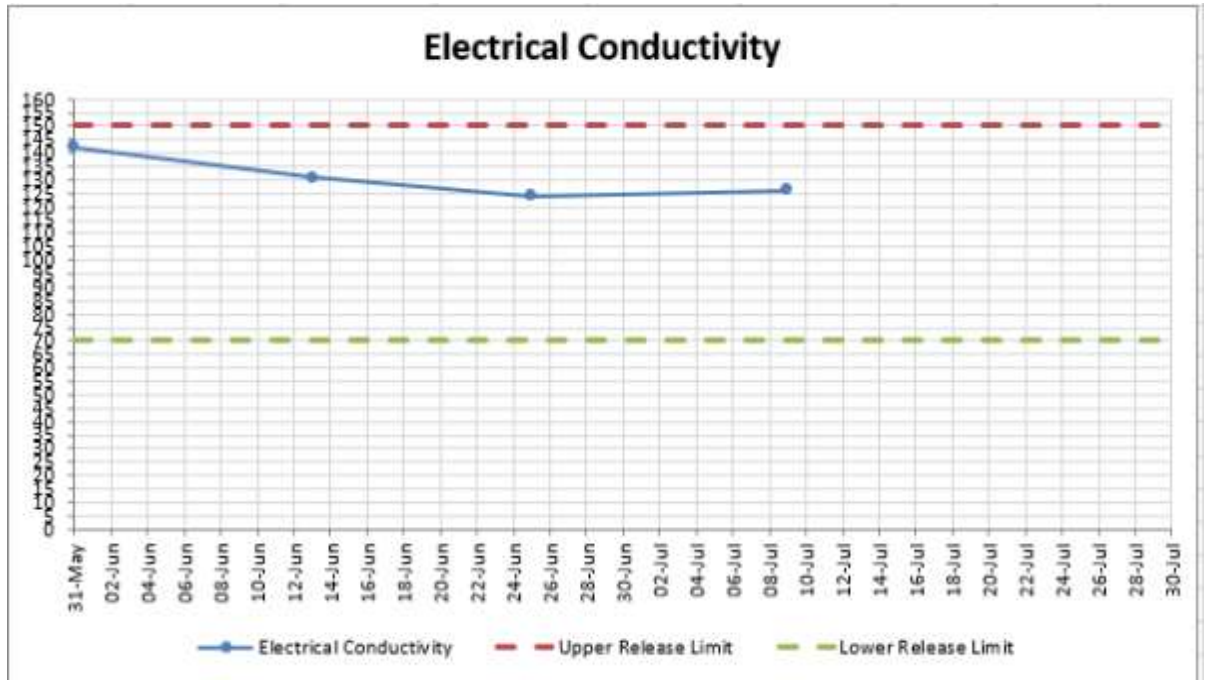
Notwithstanding the untoward salinity entering the WWTW, the EC remains within limits.

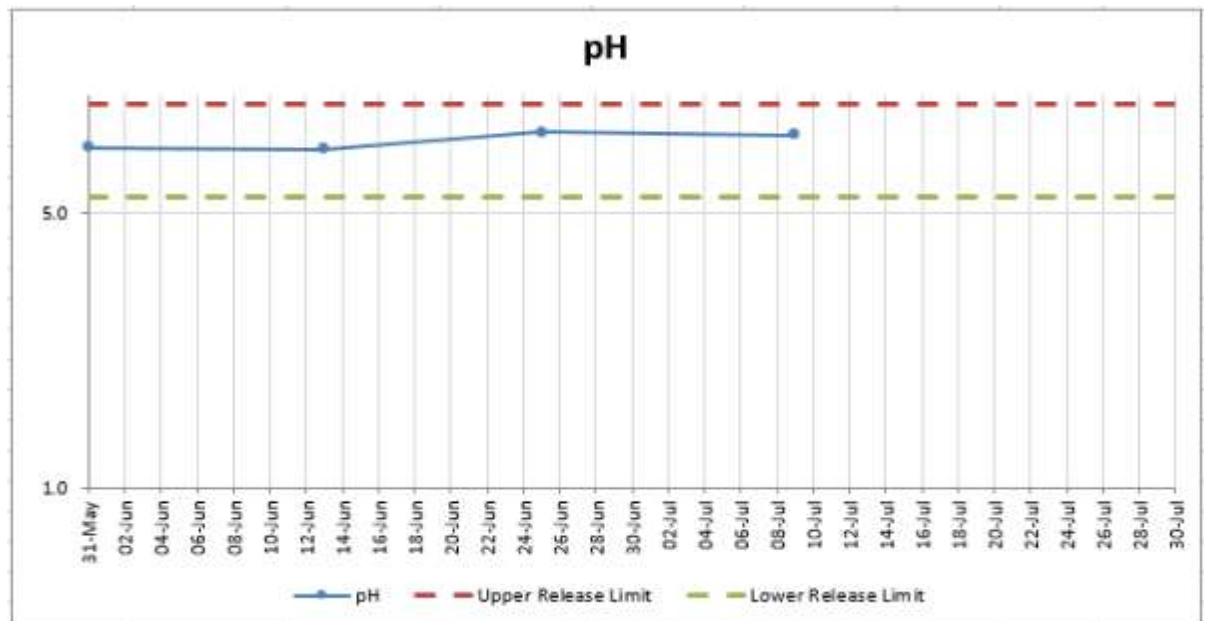
The pH remains in the middle between the upper- and lower limits. Inflow of foreign materials and supposed blood can be a contributor to the constant pH level.

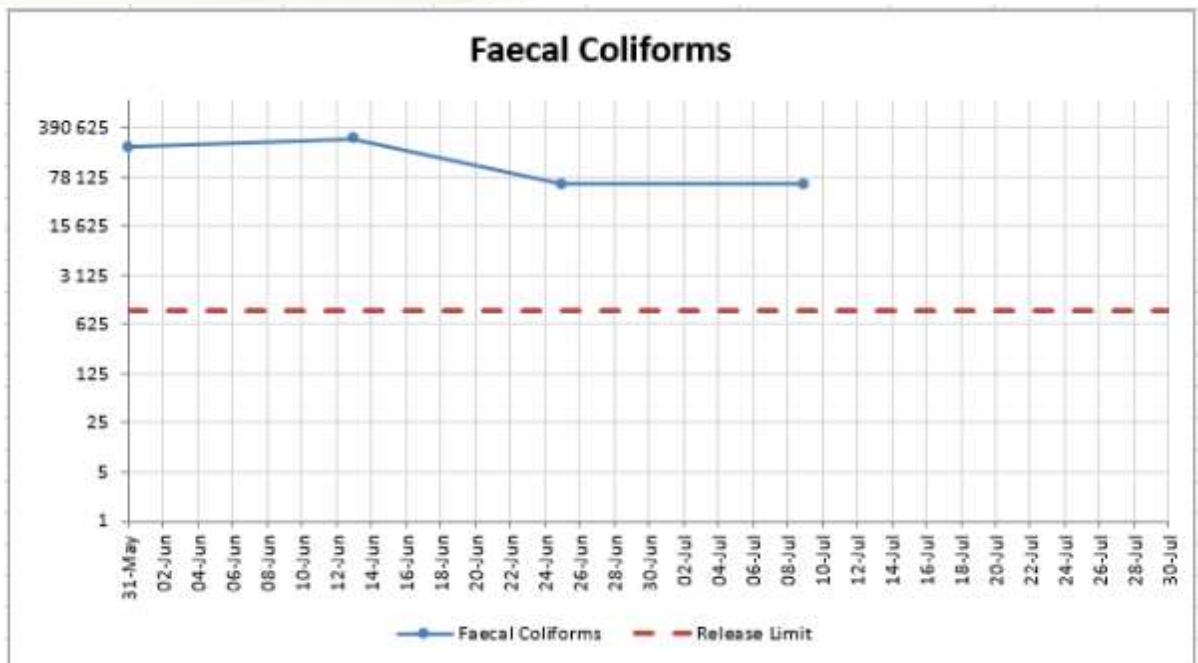
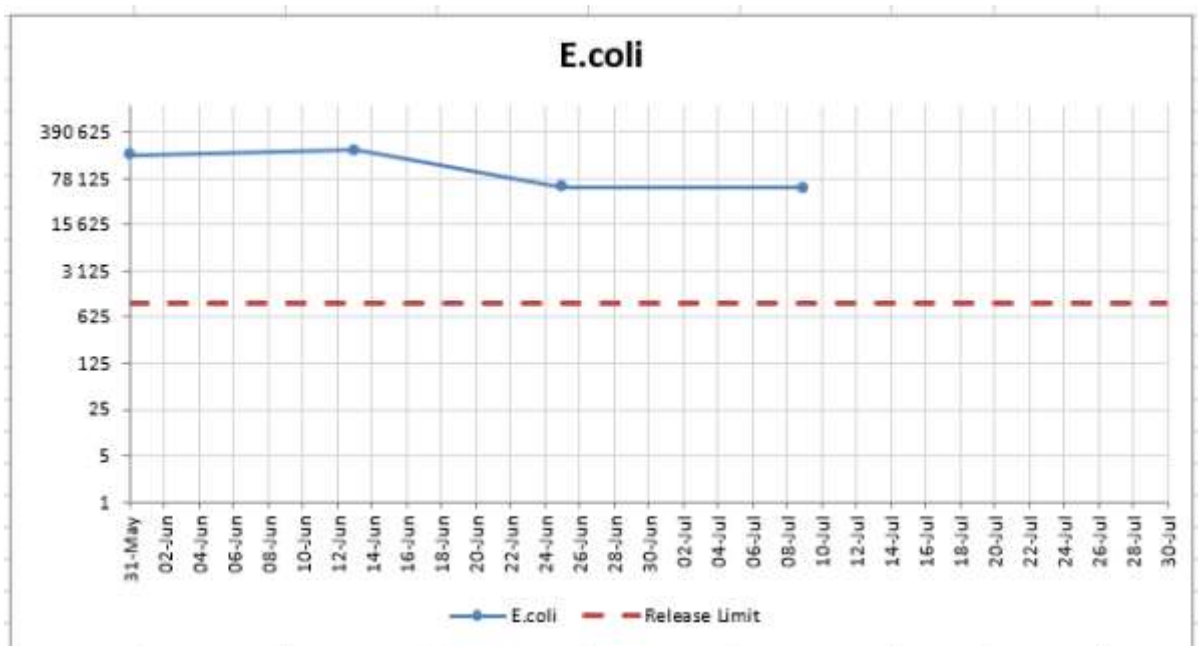
The E.coli and Faecal Coliform results nearly mirror each other. The counts on 31 May and 13 June 2019 differs slightly, with latter counts being marginally higher. With the initial shock treatment of BioSol SL36, the F:M ratio of the WWTW changed, resulting in higher E.coli and Faecal Coliform count. With the continuous use of BioSol SL36 breaking up the settled sludge, the F:M ratio started to stabilise and as the suspended solids get processed by the bacteria the E.coli and Faecal Coliform counts have started to drop significantly and moving closer to acceptable releasing levels.

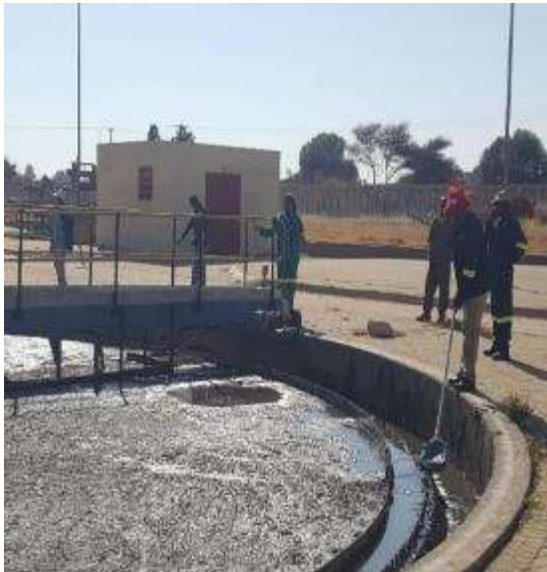
A final effluent test was taken on the **29th of July 2019**, but after collaboration with all parties involved it was decided to discard the test as staff of Mmabatho WWTW, within the same period of effluent sample testing, started with a clean-up operation of the sludge blankets within the primary settlement tanks and, instead of removing the sludge *in toto*, Mmabatho WWTW staff dispose the excessive sludge straight into the effluent weir (overflow gutter) of the primary settlement tank, which has a negative influence on water quality as can be noted on the final analyses received.

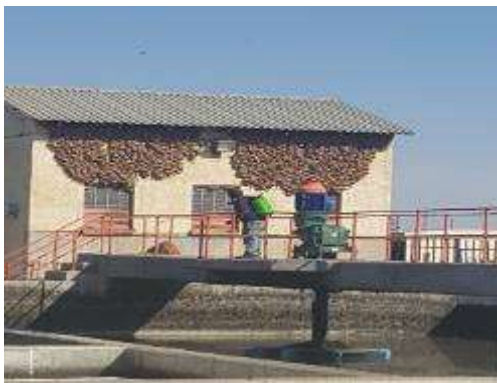
The Mmabatho Wastewater Treatment Works has lost a lot of mechanical ability over the past few years which have rendered the works largely inoperable. This has caused a lot of sludge build-up over the decades, which has caused sub-standard effluent quality as well as malodours in the area around the facility.

Some of the failures include:

- Aerator failure in aerobic zones due to Microbially Induced Corrosion (MIC) and infrequent maintenance;
- Mixer failure in anaerobic zones due to MIC and infrequent maintenance;

- Various pumps and other equipment in-operational.

MIC is corrosion caused or promoted by microorganisms, usually chemoautotrophs. It can apply to both metals and non-metallic materials.

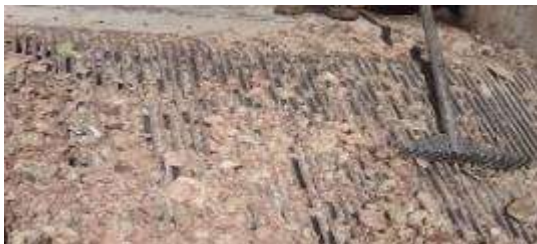
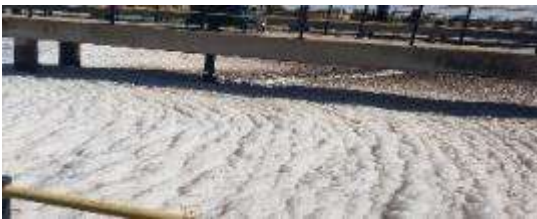
Waste from a nearby abattoir is found in the incoming wastewater on a daily basis, this includes blood, fatty residue as well as congealed fats hardened into heavy clumps. From what can be ascertained, the abattoir heats up the waste to make it run easier to the Mmabatho WWTW, after which the fats harden. The organic load from the abattoir causes high nitrite/nitrate and phosphate levels which contribute to the formation of foam.

Loss of mechanical ability and with the influx of wastewater from a nearby abattoir has also hampered the Dissolved Oxygen in the system - which in turn has slowed down aerobic biological processes. For this reason, the bioremediation and bio-augmentation are vitally important.

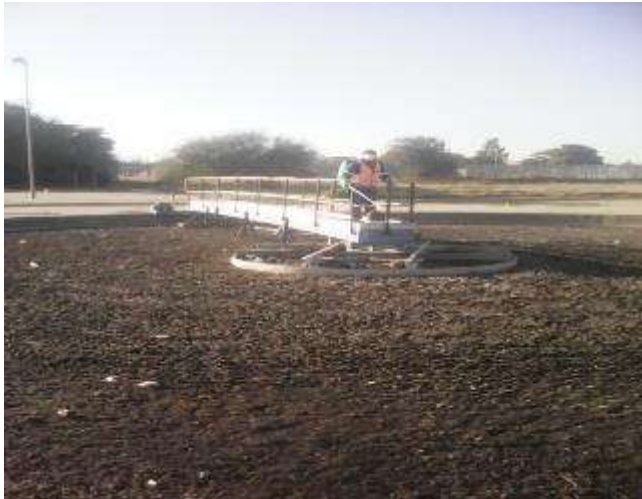
BEFORE

Clarifiers not working and excessive sludge formed a crust.

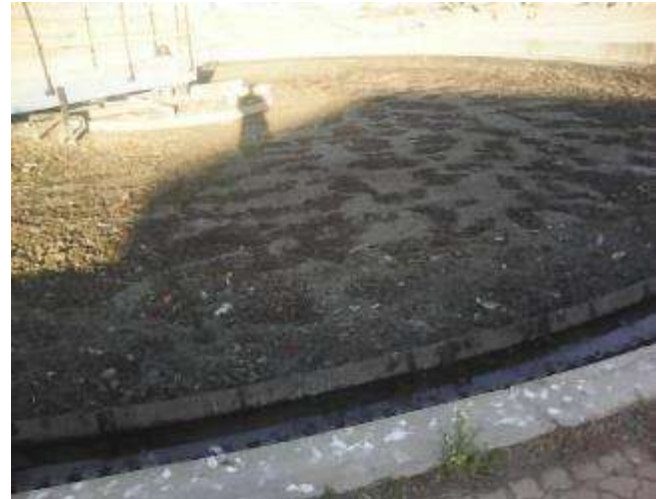
AFTER

With the addition of BioSol SL36 the crust started to disperse.

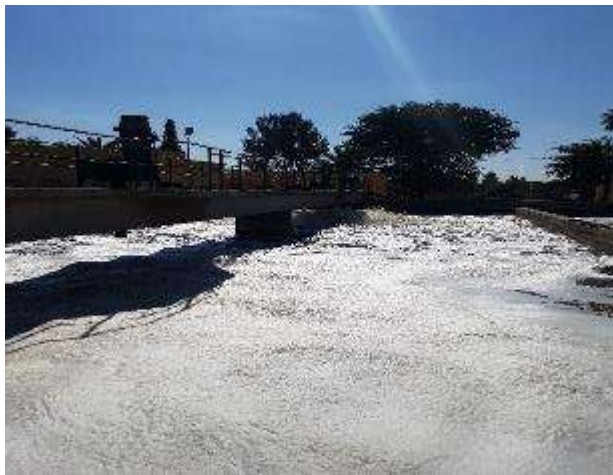
BEFORE

Water within the BNR covered with foam, possibly due to high inflow of phosphate.

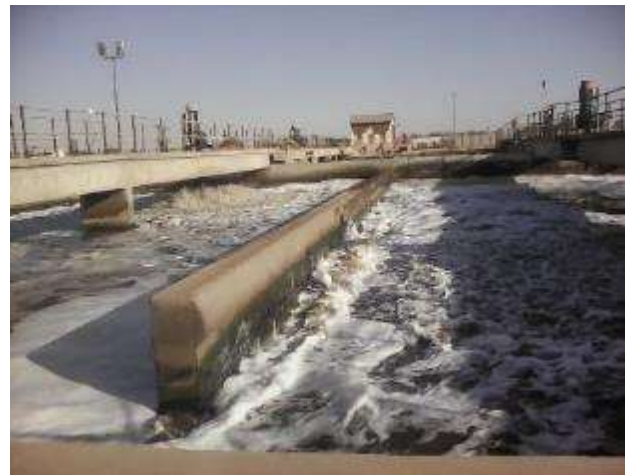
AFTER

Water much clearer with the addition of BioSol SL36 and foam subsided.

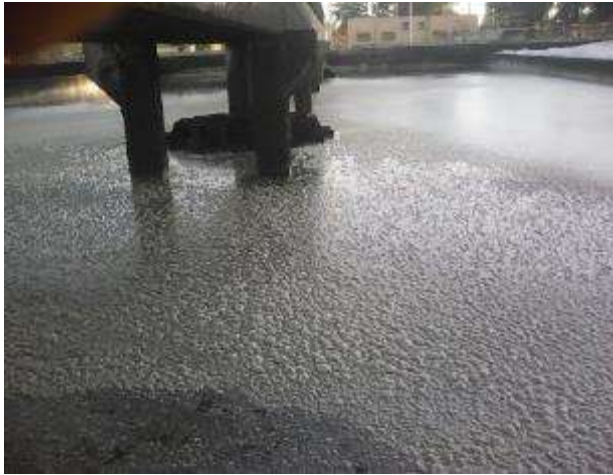
BEFORE

BNR before BioSol SL36 added. The water had a dark colour and foam levels high.

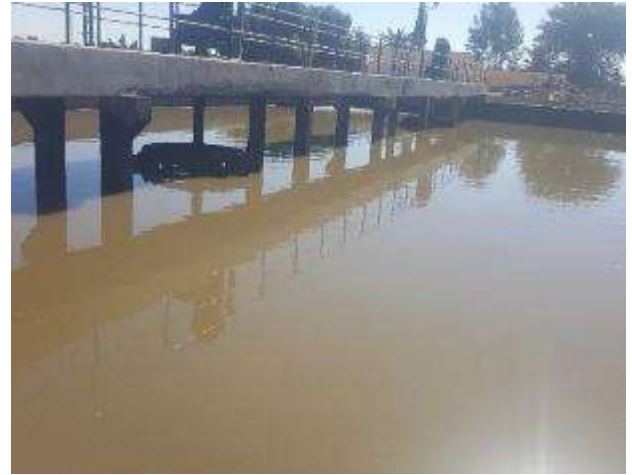
AFTER

After adding BioSol SL36 colour of water changed to a lighter brown.
